**Transformer Diagnose on practical Samples**

Janusz Szczechowski, Dr. Peter Werle, ABB AG, Transformer Service Center Halle, Germany

### Transformer Life Management 2014 Transformer Diagnosis on Practical Examples

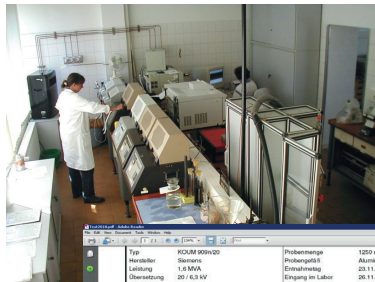
Komponente		Ergebnis in mg/l	Messwert (ppm)	Referenz (ppm)	Beurteilung
5-Hydroxymethyl-2-Furfural (5HMF)	0.12	-	-	-	-
2-Furfuryl alcohol (2FOL)	< 0.05	-	-	-	-
2-Furfural (2FAL)	15.52	5	-	210 %	-
2-Acetyl furane (2ACF)	0.11	-	-	-	-
5-Methyl-2-Furfurol (5MEF)	0.80	-	-	-	-
Gesamtgehalt	16.55	5	-	327 %	-

**Bewertung:** Basierend auf den vorliegenden Messergebnissen weist die Analyse der Furanfraktionen auf einen höheren DP-Wert des Papiers im Bereich von 100 bis, wobei dieser an Brennstoff beengteren Stellen auch wesentlich niedriger sein kann.

**Empfehlung:** Aufgrund der stark gestiegenen Feststoffkonzentration sollte eine Entschneidung in Erwägung gezogen werden.

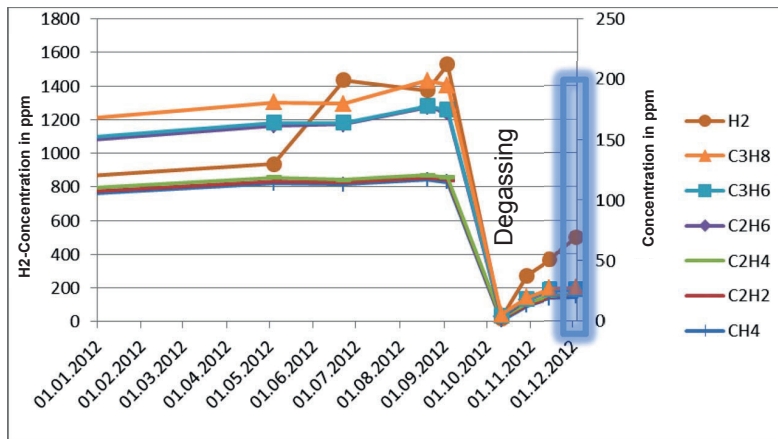
Example 1  
DGA Trend

- Time frame 01/2012 – 12/2012

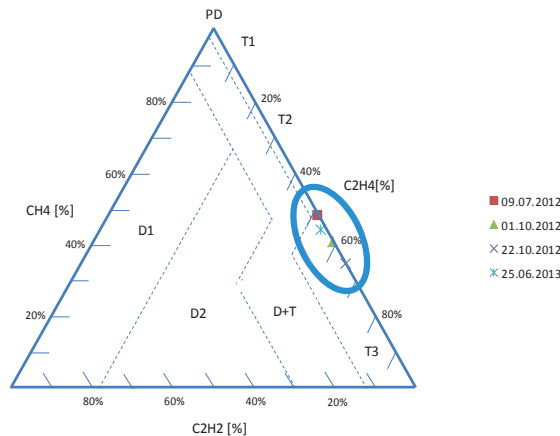
- Trend in Duval triangle

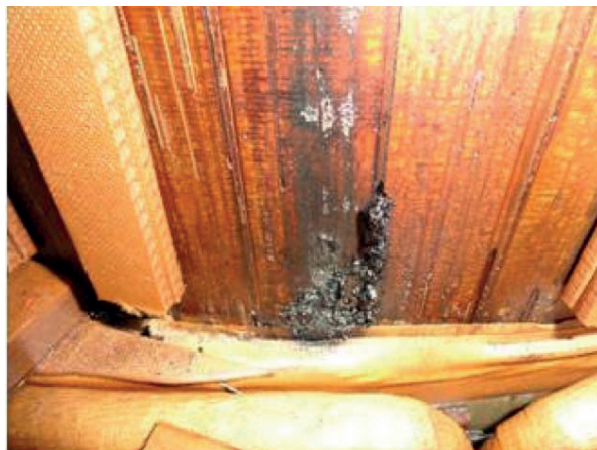
- Transportation to ABB Service Center
- Visual inspection of the active part:
  - Hot spot at the core

C<sub>2</sub>H<sub>4</sub>/C<sub>3</sub>H<sub>6</sub> >=2-3  
-> Core Problem
