**TRANSFORMER-LIFE-MANAGEMENT  
CONFERENCE**

**Challenges in continuous monitoring of  
transformer insulation**

**Wojciech Koltunowicz**  
**OMICRON electronics GmbH**

**Laurentiu-Viorel BADICU**  
OMICRON Energy Solutions GmbH, Berlin, Germany

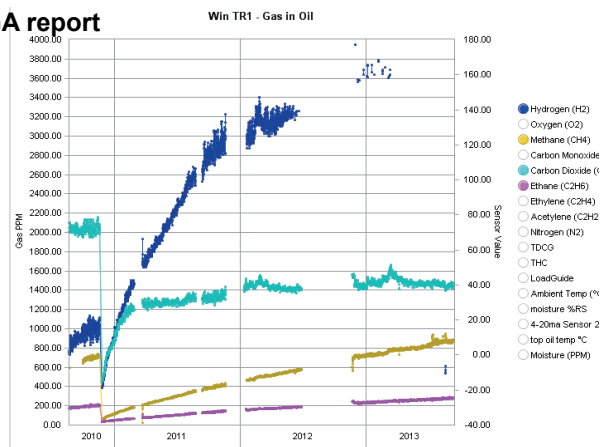
#### On-line DGA report

- H<sub>2</sub> and CH<sub>4</sub> steady increase → oil decomposition under ongoing PD
- CH<sub>4</sub> and C<sub>2</sub>H<sub>6</sub> → extreme overheating of the mineral oil and adjacent metals
- Low concentration of CO → no paper insulated parts involved

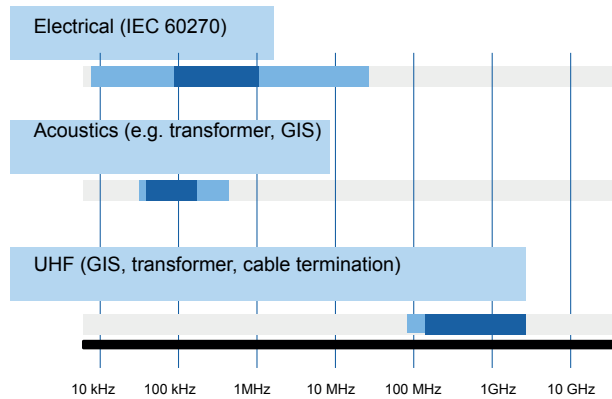
### PD detection methods

**Electrical:**  
Conventional (according to IEC60270)  
HF/VHF/UHF

**Nonelectrical:**  
Acoustic  
Optical  
Chemical

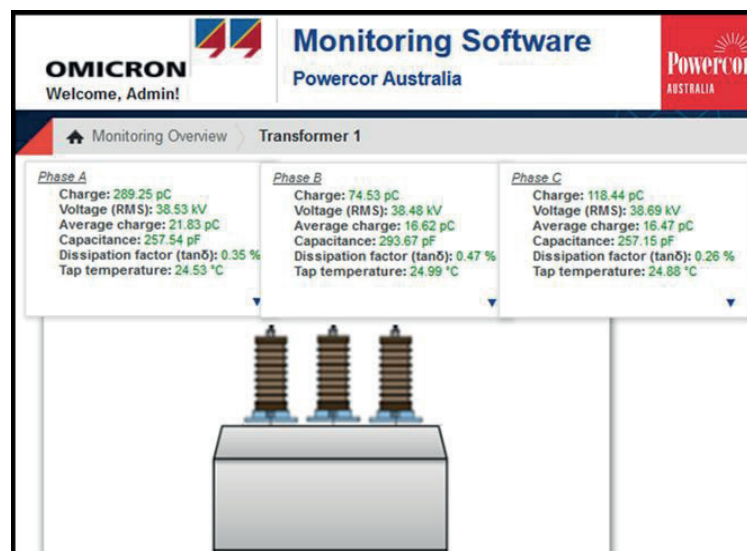
### Monitoring Software - GUI

- State-of-the art database system for long-term data storage and retrieval
- Web-based data access & visualization
- Different user roles/logins:
  - Operator:
    - Overview of full system setup
    - View all data with free configurable charts and diagrams
    - Confirm warnings and alarms
  - Administrator: As operator, plus
    - Configuration of all monitoring parameters
    - Set and change warning and alarm rules

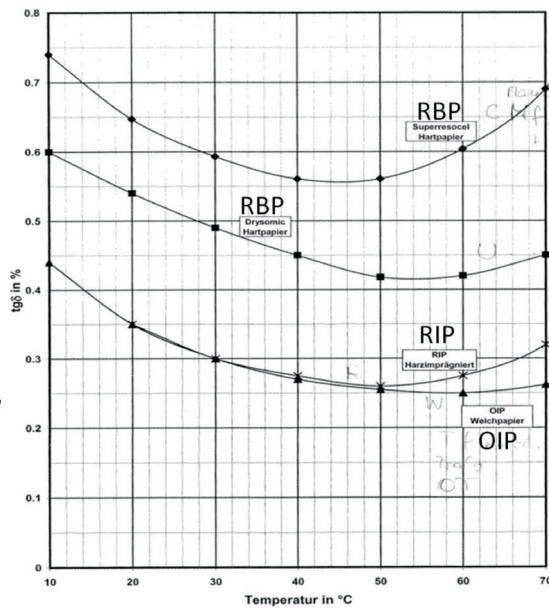
Temperature correction of DF

$$\tan\delta \downarrow 20^\circ = c_{Mat}(\vartheta) * \tan\delta \downarrow B$$

- $\vartheta$  is the bushing temperature
- $c_{Mat}$  is a correction factor depending on the insulation system of the bushing (OIP, RIP, RBP-Drysonic and RBP-Superresocel)

Temperature dependence of the dissipation factor [Karl Frey, Micafil]

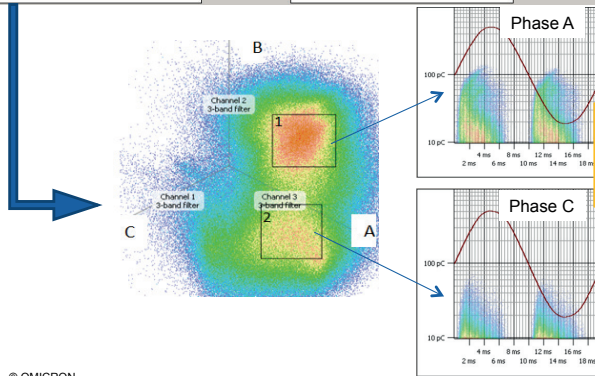
#### Partial discharges analysis – electrical method

Acoustic PD localization  
measurements  
are recommended

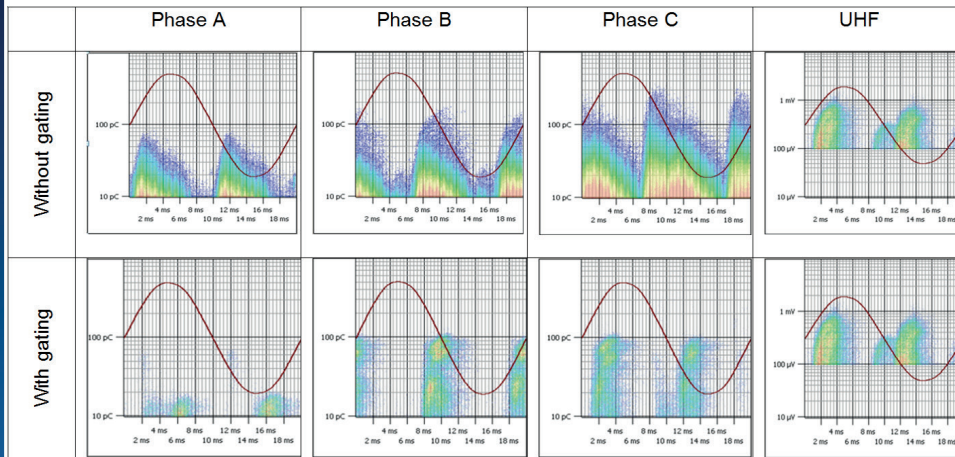
### Rejection of disturbances by UHF gating

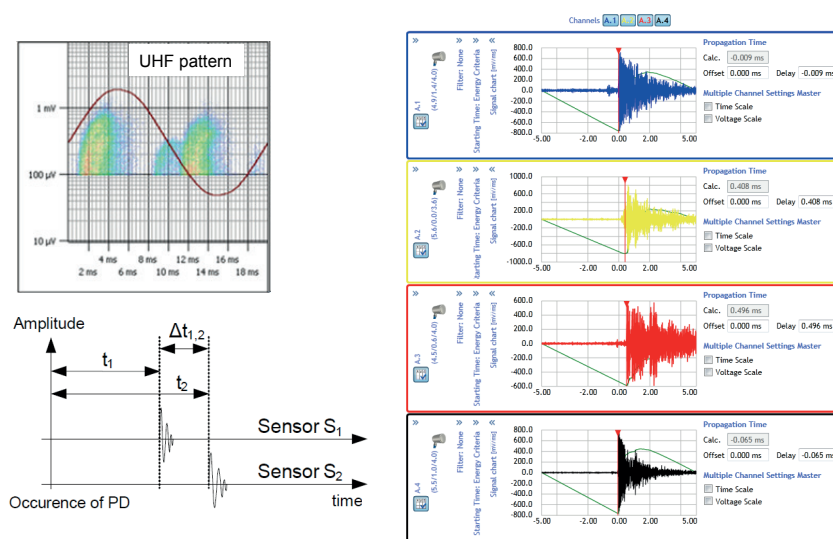
### Acoustic measurements triggered by the UHF signal

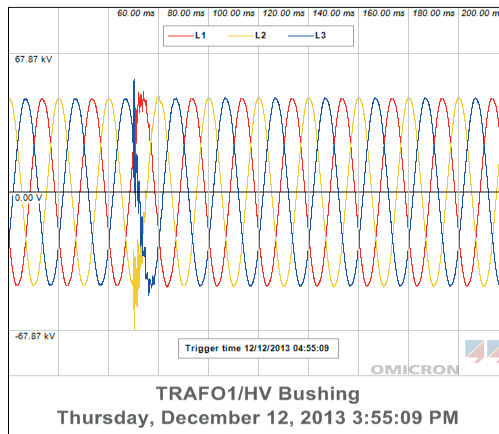
### Transient Over-voltages

20 transient over-voltages were recorded → highest amplitude 1.77 p.u.

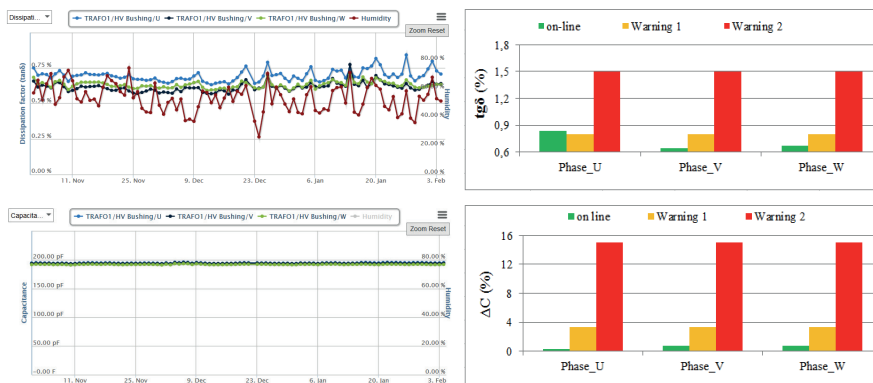
#### Absolute values of capacitance and DF

Capacitance variation and dissipation factor limits for RBP bushings

$U_N$ [kV]	$\tan \delta$ [%]	$\Delta C$ [%]
123	2.0	20
245	1.5	15
420	1.0	10

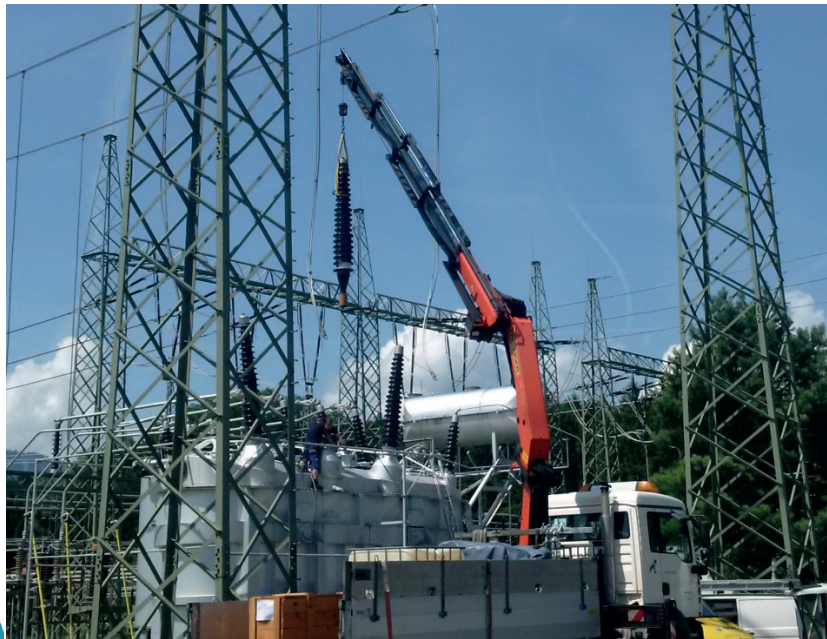
41

## Case study 2: Internal inspection

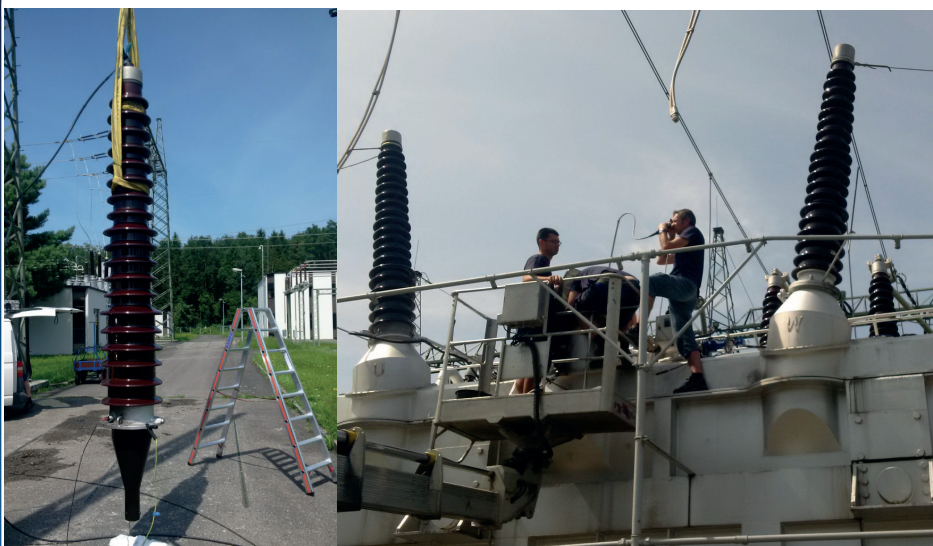
42

## Case study 2: Internal inspection
