Transformer Life Management Symposium Merseburg 2015

M. Krüger, OMICRON, Klaus, Austria
michael.krueger@omicron.at

S. Hoek, OMICRON Energy, Berlin, Germany
stefan.hoek@omicron.at

NEW TRENDS OF DIAGNOSIS ON POWER TRANSFORMERS AND ASSOCIATED COMPONENTS

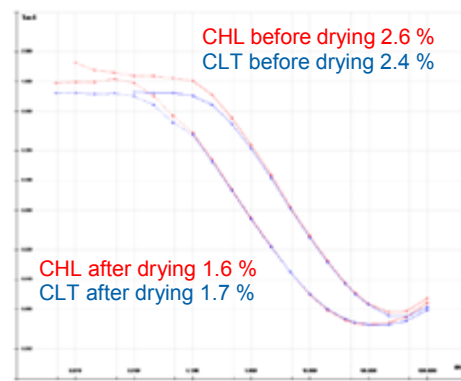
Fig. 1 Water content before and after drying

After drying the measurements were repeated. Table 1 shows the moisture and the capacitance and tan δ at 50Hz before and after drying. Figure 1 shows the results in the frequency domain (FDS). The moisture of the insulation gap HV to LV was reduced from 2.6% to 1.6%, the moisture of the insulation gap LV to TV was reduced from 2.4% to 1.7%.

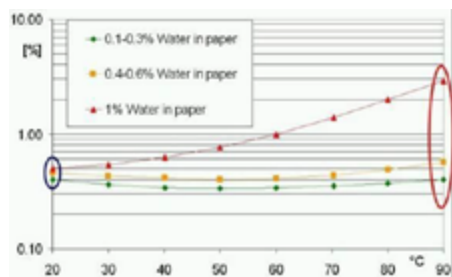
Fig. 2 $\tan \delta (T)$ at 50Hz with different moisture

Bushings with high moisture in the insulation show increased 50/60Hz tan δ values particularly at higher temperatures. Figure 2 shows the Dissipation Factor (DF) of OIP bushings at 50Hz for different water contents as function of the temperature [5], in figure 3 it can be seen that the DF at low frequencies

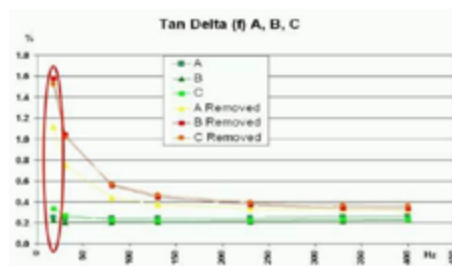
Fig. 3 $\tan \delta (f)$ at 30°C with different moisture

is a very sensitive parameter also at ambient temperatures. This is important if measurements are made on built-in bushings which cannot be heated.

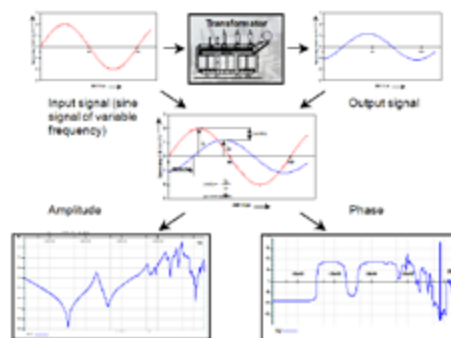
Fig. 4 Principle operation of SFRA

Sweep Frequency Response Analysis (SFRA) has turned out to be a powerful, non-destructive and sensitive method to evaluate the mechanical integrity of windings and the core within power transformers by measuring the electrical transfer functions over a wide frequency range. This is usually done by injecting a low voltage signal of variable frequency into one terminal of a transformer's winding and measuring the response signal on another terminal (figure 4). This is performed on all accessible windings following according guidelines [8], [9]. The comparison of input and output signals generates a frequency response which can be compared to reference data, to other phases, or to sister transformers. The core-and-winding-assembly of power transformers can be seen as a complex electrical network of resistances, self- and mutual inductances, ground capacitances and series capacitances. The frequency response of such a network is unique and therefore it can be considered as a fingerprint. Geometrical changes within and between the elements of the network cause deviations in its frequency response. Differences between FRA fingerprints and the results of an actual measurement are an indication of positional or electrical variations of the internal components.

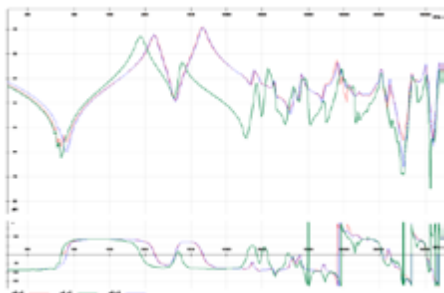
Fig. 5 FRA LV winding x1=red, x2=green, x3=blue

A transformer with 110kV / 30kV was switched off by the differential protection relay after a ground fault in a nearby overhead line. The FRA result is shown in figure 5.

The middle phase x2 (green line) is totally different from x1 (red line) and x3 (blue line). After opening the transformer an interruption of one of the parallel windings was detected (figure 6).

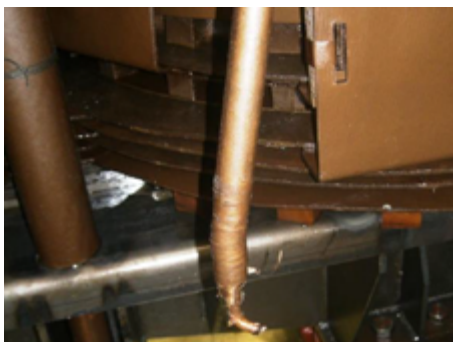
Fig. 6 Interruption in one branch of a LV winding

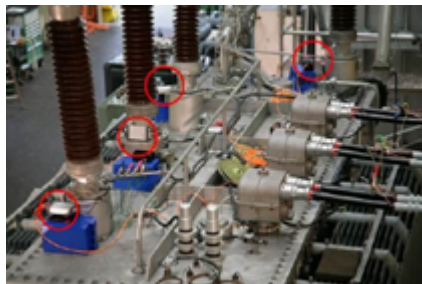
Fig. 7 PD measurement on a 110kV transformer

Figure 7 shows a PD measurement setup with four simultaneously measuring channels which are connected to the three HV bushings and the star point. It can be seen in figure 8 that the three different clusters in the 3PARAD diagram are generated by three different PD sources: statistical noise, pulse disturbances and inner partial discharges. As an enhancement of 3PARAD the 3-Center-Frequency-Relation-Diagram (3CFRD) was introduced as an additional tool for PD data analysis and PD fault separation in real-time on single-phase test objects [12].

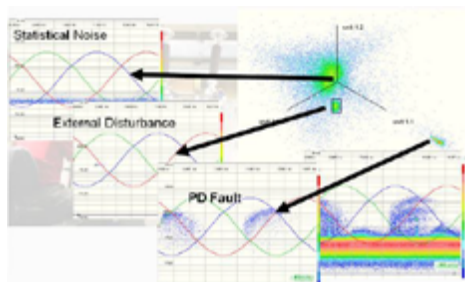
Fig. 8 3PARV filtering on the 110kV transformer

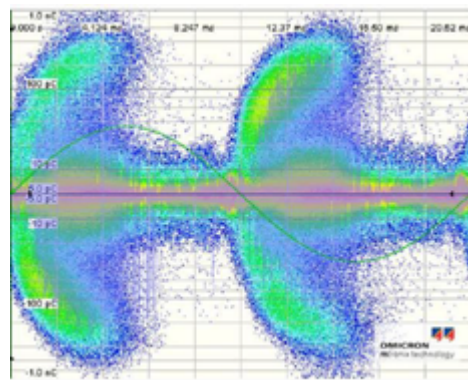
Fig. 11 PRPD pattern without 3CFRD filtering

The use of this principle is shown in two examples. The first example is the 3CFRD measurement on a high voltage bushing. Figure 11 shows the phase resolved pattern of different PD sources. The overlaying of different patterns doesn't allow a detailed analysis. Figure 12 shows a separated pattern of one source by 3CFRD filtering.

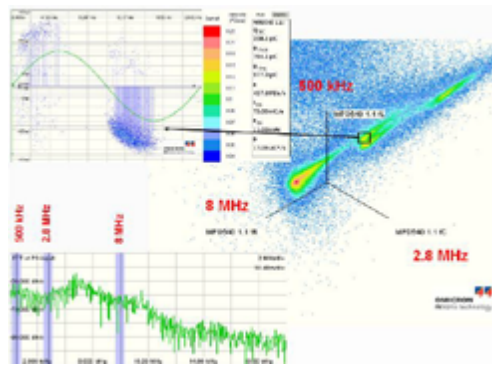
Fig. 12 PRPD of one PD source with 3CFRD filtering

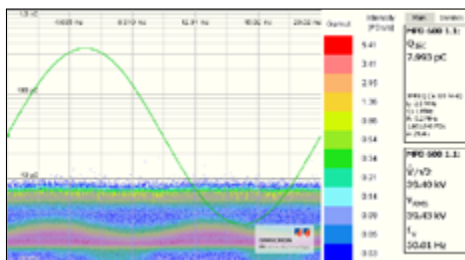
Fig. 13 PRPD of one PD source without 3CFRD filtering

A second example for 3CFRD filtering is a measurement on a dry-type cast resin transformer. Figure 13 shows the PRPD at app. 40kV. The noise is about 10pC. An analysis with the 3CFRD is shown in figure 14. The filtered signal (figure 15) shows a clear pattern of internal void discharges with 5pC, although the PD's are below the noise level.

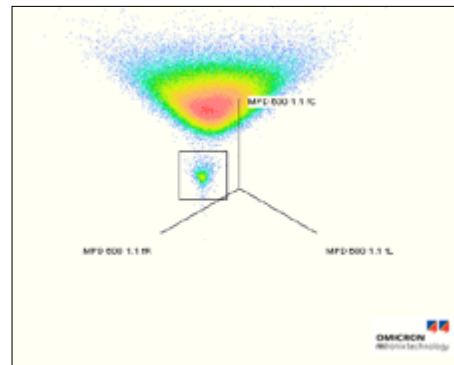
Fig. 14 3CFRD of the measurement in fig. 13

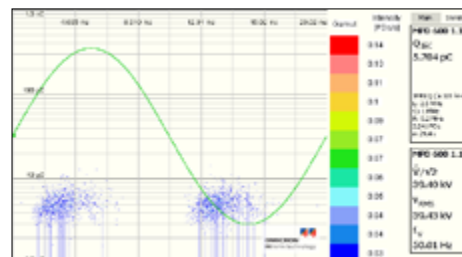
Fig. 15 PD pattern of voids with 3CFRD filtering

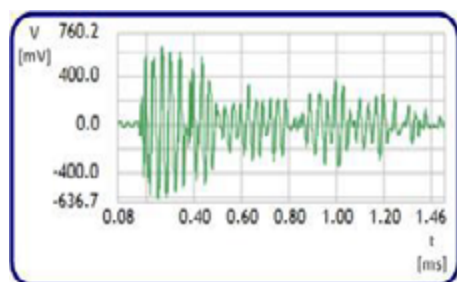
Fig. 16 Acoustical signal from a partial discharge

Due to the resonant character of the sensors, the measured acoustic PD signal is inherent overlaid by oscillations as illustrated in figure 16. For that reason the determination of the frequency content and proper signal form is difficult. Using the difference in arrival time of the acoustic PD signal at multiple sensors, algorithms compute the location of the PD source. The complex physical processes involved in sound propagation and the

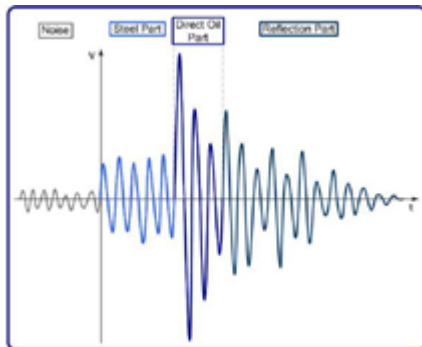
Fig. 19 Acoustic PD signal components according to different propagation paths

The measurable direct oil signal at the sensor position depends on the intensity of the PD event and on the damping in the propagation path. Therefore, the attenuation by core, winding, transformer board, flux shielding etc. should be as low as possible. For that reason, the search for sensor positions that ensure good signal quality is essential during measurement procedure.

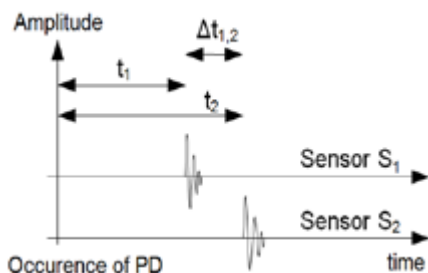
Fig. 20 Absolute and relative times in a two-sensor-setup

The relative arrival times at different sensor positions lead to time differences ($\Delta t_{1,2}$). These time lags are the only available data in all-acoustic measurements, when the data acquisition is triggered by the acoustic signal at one of the sensors. If the time delay between occurrence of a

PD and the arrival of the associated acoustic wave is available, the absolute propagation times (t_1 , t_2) from source to sensor can be used for localization (figure 20). The exact timing of the emission of the PD signal can be estimated e.g. by an electrical PD measurement according to IEC 60270 or a measurement in the ultra-high frequency (UHF) range. In the latter case, sensors within the transformer walls can be used to collect the high frequency electromagnetic wave that is emitted during PD. The principle and a measurement setup are shown in figures 21, 22 and 23.

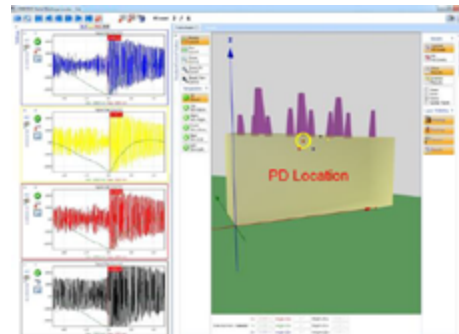
Fig. 29 Location of one PD source at V

The transformer was taken out of service to investigate the reason for this behaviour. The fault could be located with the acoustic PD system PDL600 (figure 28) at the oil end of the V and W bushings (figures 29 and 30). The bushings were removed and the damage at the leads between windings and bushing could be seen (figure 31).

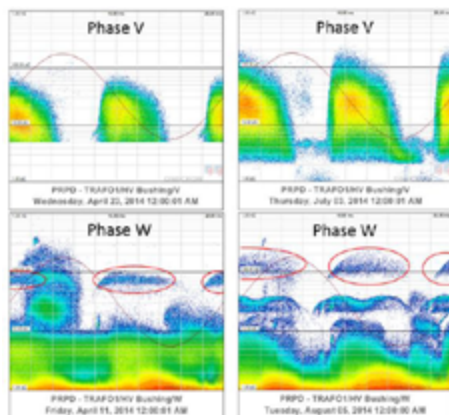
Fig. 27 Increase of PD at phases V and W

partial discharges particularly at the bushings of phases V and W (figure 27). The left pictures in figure 27 show the PD patterns in April the right ones of phase V in July and of phase W in August.

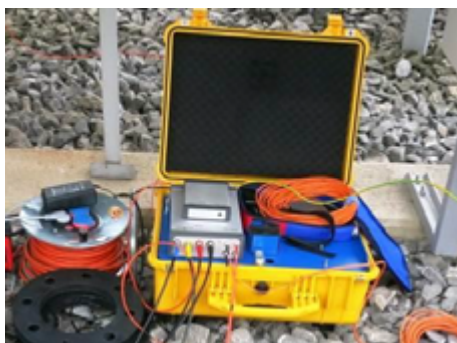
Fig. 28 PD locator PDL600

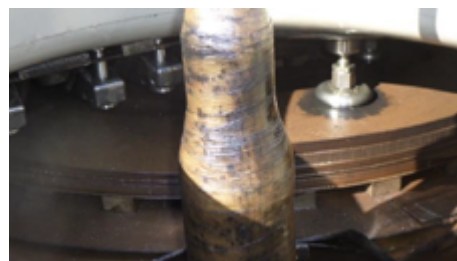
Fig. 31 X-wax at the high voltage leads

Due to partial discharges, X-wax was produced at the insulation paper and inside the windings. X-wax is a solid material which is formed from mineral oil as a result of electrical discharges and which consists of polymerized fragments of the molecules of the oil. If it is built inside the oil ducts, the cooling of the transformer can be blocked.

A repair of these faults would have meant that the transformer had to be rewound at least partially, at worse completely. Due to the age - the transformer was built in 1967 - and its condition it was decided to scrap it prior any hazard in service.
